ENGINEERING NEWS

Vol. 62. No. 23. 220 Broadway, New York, December 2, 1909.

The Partial Failure Through Undermining of the Zuni Dam, New Mexico.

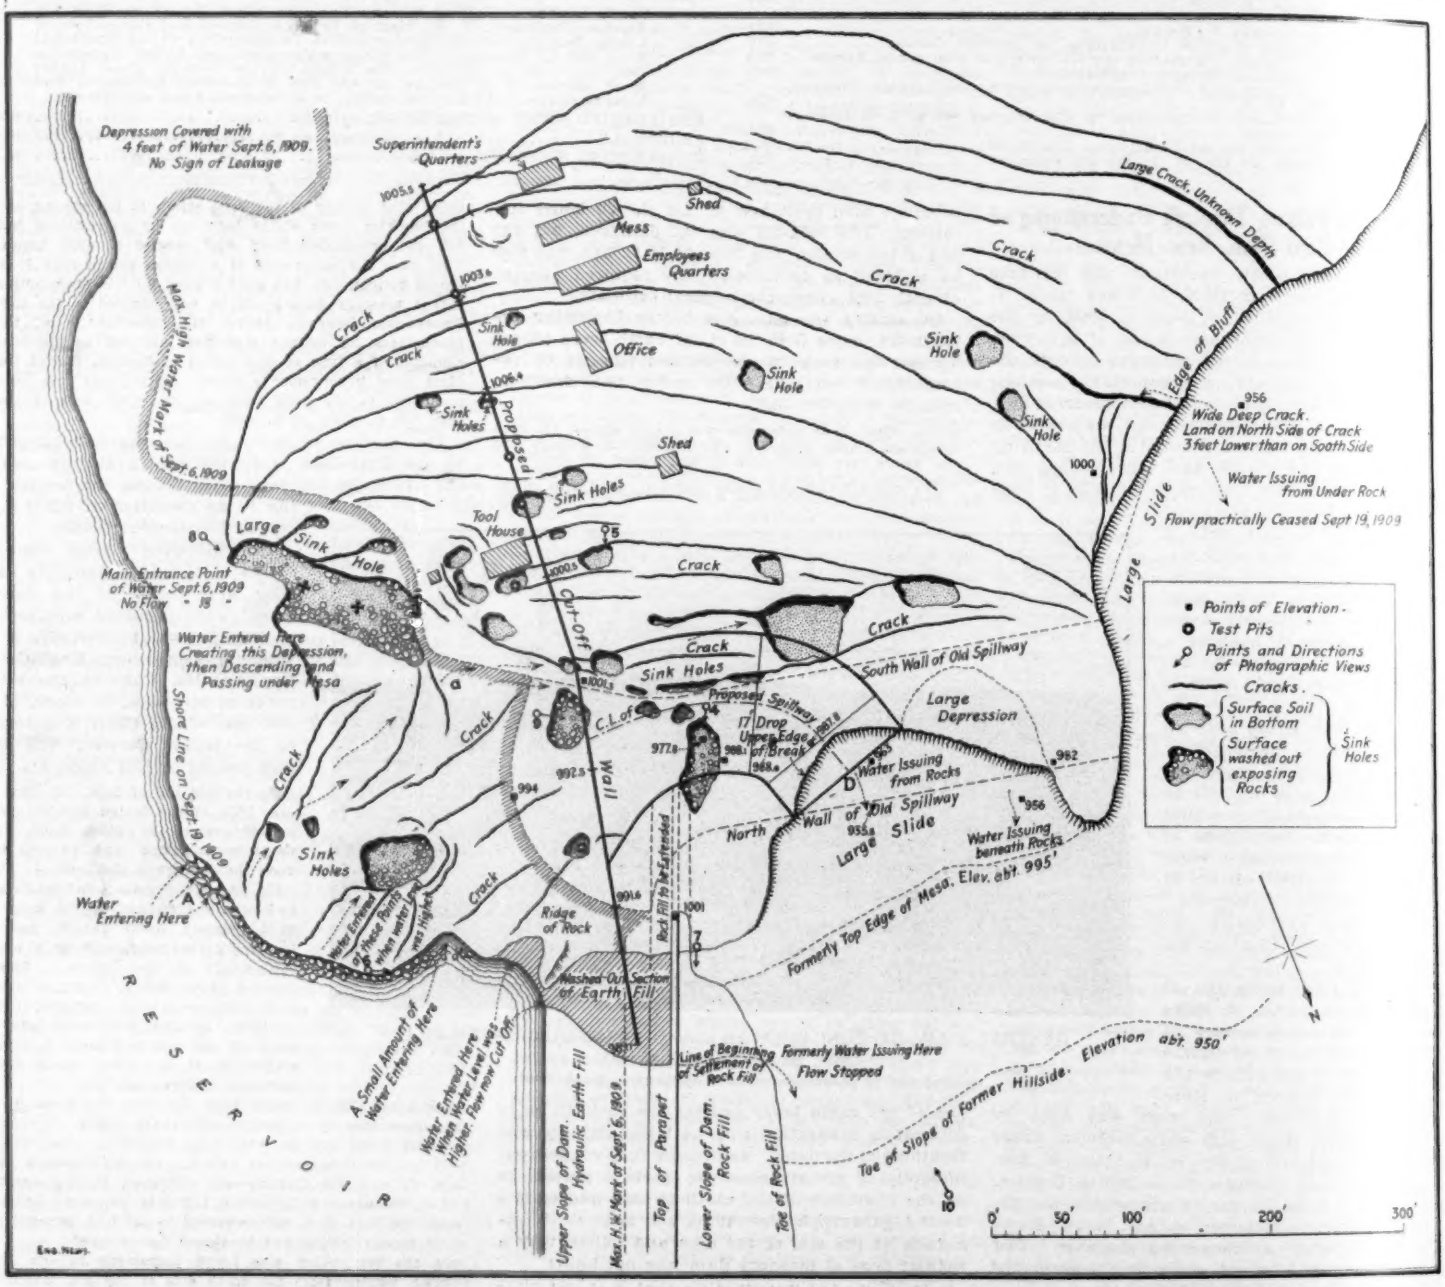
The spillway, south abutment and extreme south end of the Zuni Dam, at Black Rock, N. Mex., were undermined on Sept. 6, 1909, by the passage of water underneath a cap of lava rock which flanked the dam and extended beneath the spillway. The spillway, or considerable portions of it, dropped 7 ft.; there was a settlement of 9 ft. at the junction of the spillway and the abutment of the dam; and a small portion of the earth fill at the south end of the dam was washed out, and there was a 5-ft. settlement some 30 ft. long in the earth-fill at the north end of the dam. The main body of the dam, which is a combination of rock-fill and hydraulic-earth-fill, appears to be uninjured. The undermining of the lava cap extended beneath a large area of the mesa, far beyond the dam and spillway (see Fig. 1).

We found the mesa south of dam had been undermined by the water, approximately 5,000 sec.-ft. passing under the same, causing a bad settlement of the mesa. This reached about 600 ft. south of the dam. The underflow destroyed the spillway, injured the south abutment of the dam and made a 9-ft. settlement at the point where the dam and spillway connect.

For about 600 ft. south from the dam the mesa has the appearance of a severe earthquake shock. Cracks and sink holes may be seen in all directions. The main body of the dam remains intact. On the morning of Sept. 5, a slight leakage was observed at the north end of the dam. It measured 124 gals. per min., water clear. On Sept. 6, it had increased to 467 gals. per min., water muddy. This was blanketed and stopped.

(Map as on Sept. 20, 1909. The underflow that caused damage was first observed on Sept. 5 and settlement of the spillway and dam occurred on Sept. 6, 1909.)

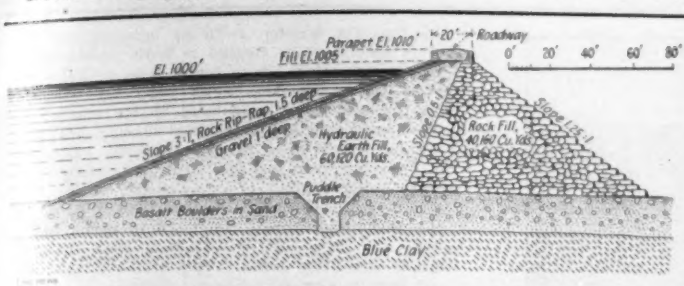
FIG. 2. CROSS-SECTION OF ZUNI DAM.
(Redrawn from the second edition of Schuyler's "Reservoirs.")

The maximum height of the dam is 70 ft. Its cross-sectional dimensions, as well as the disposition of the rock and the earth of which it is composed, are shown by Fig. 2, which we have reproduced from Mr. Schuyler's book already mentioned. The crest of the rock-fill portion of the dam was 5 ft. wide and 720 ft. long. The stones on the down-stream face were placed by steam-operated derricks and the steps shown are 18 ins. high. The rock-fill interior mass "was chinked carefully with small stones."

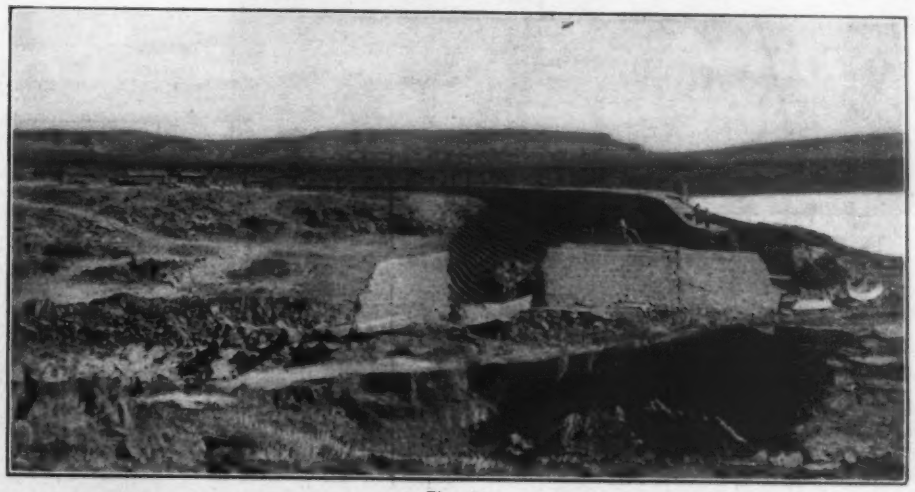
FIG. 3. LOOKING UP AGAINST THE LOWER OR ROCK FACE, AND SHOWING SETTLEMENT AT SOUTH END.
(This view also shows the lava rim-rock west of the spillway through which water was escaping from the reservoir during the investigation of the accident.)
